**PERFORMANCE INNOVATION LABORATORIES**

**FAILURE ANALYSIS OF  
DROP TESTS FOR CRANE  
TOL0801002**

**Date: July 30, 2009**

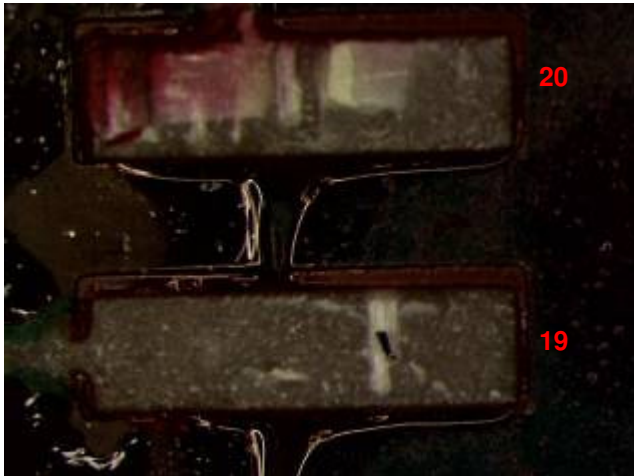
**Figure 3: board 84, U17, pins 19-20, board side**

Pin 20 of this CLCC-20 package, which is a corner pin located in the top left corner of the part., shows die penetration between the pad and the board along approximately 10% of the pad length. This indicates that pad cratering was present prior to prying the component off of the board. There appears to be little or no dye penetration on pin 19.

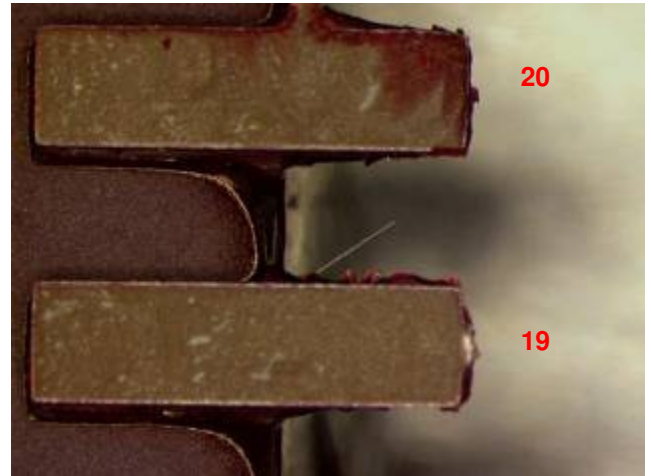
**Figure 4: board 84, U17, pins 19-20, comp. side**

The CLCC-20 showed pad cratering occurring on only one corner lead. The TSOP-50 on the other hand showed a number of leads at each corner failing. The exception to this was board 86 which showed pad cratering on the two right hand corners of the board only.

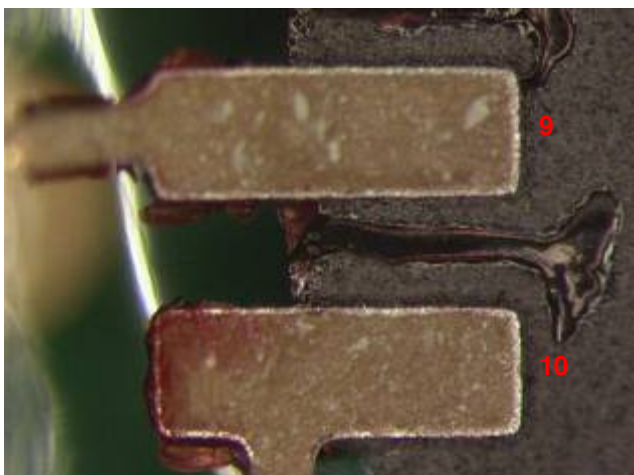
**Figure 5: board 84, U15, pins 9-10, board side.**

Pin 10 of this QFN-20 package, which is a corner pin, shows die penetration between the pad and the board along approximately one third of the pad length. This indicates that pad cratering was present prior to prying the component off of the board. There appears to be little or no dye penetration on pin 9. This example is typical of the pad cratering that was observed.

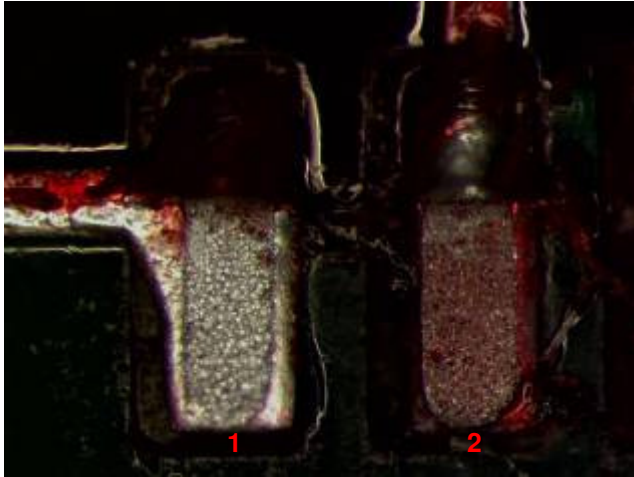
**Figure 7: board 60, U27, pins 1-2, board side**

Pin 1 of this QFN-20 package, shows some evidence of die penetration through the bulk solder, indicating that a fracture was present prior to prying the component from the board. The penetration covers less than 25% of the solder surface. Pin 2 shows almost complete die penetration across the whole pin. The fracture appears to include the intermetallic surface.

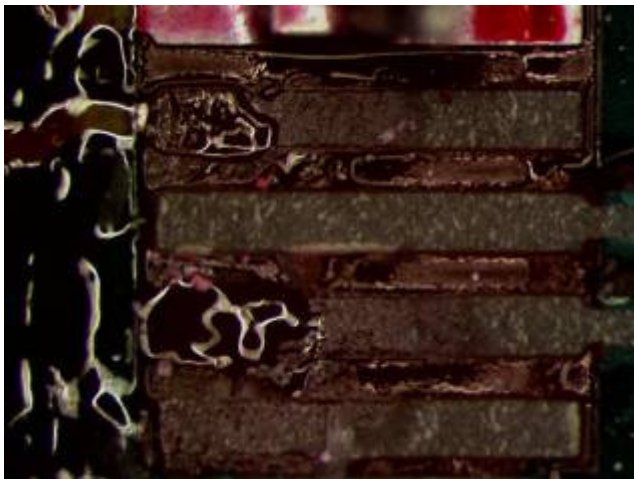
**Figure 9: board 81, U57, pins 109-112, board side**

Only one of the ten TQFP-144 exhibited full dye penetration of any lead. It showed signs of pad cratering in the bottom right corner (Figure 9 and 10). Of the other nine components tested, most of the solder joints survived; it was the leads themselves that broke during the prying portion of the dye and pry test.

Pins 109 to 112 on this board were the only pins on any of the ten TQFP-144 package to exhibit mechanical failure. Dye penetration was observed over the entire surface of the pin. These pins are located at the bottom right hand corner.

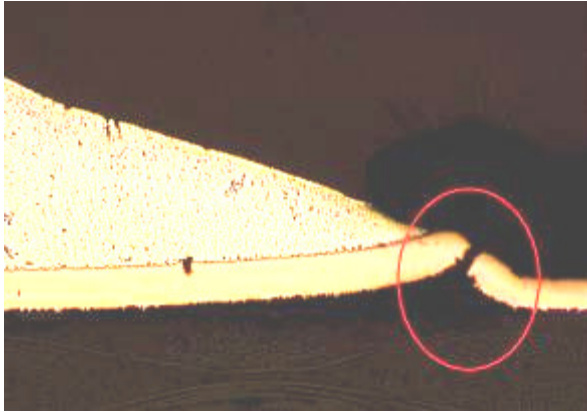
**Figure 11: board 84, U14, pin 18, 100x**

All three electrical failures were clearly evident through cross sectioning. Boards 84 U14 (figure 11) and 86 U15 (figure 12) showed significant pad cratering as well as broken traces. Board 85 U57 (figure 14) showed complete cracking of the solder joint. In addition to pad cratering, board 86 U15 (figure 13) showed evidence of partial cracking in the bulk solder.

Both U14 shown in figure 11 and U15 shown in figure 12 show a broken trace which can explain the corresponding electrical failure observed with these two parts. Records from the drop test show that these parts failed after 3 and 18 drops respectively. Board 86, U15 also exhibits pad cratering as indicated by the arrows.

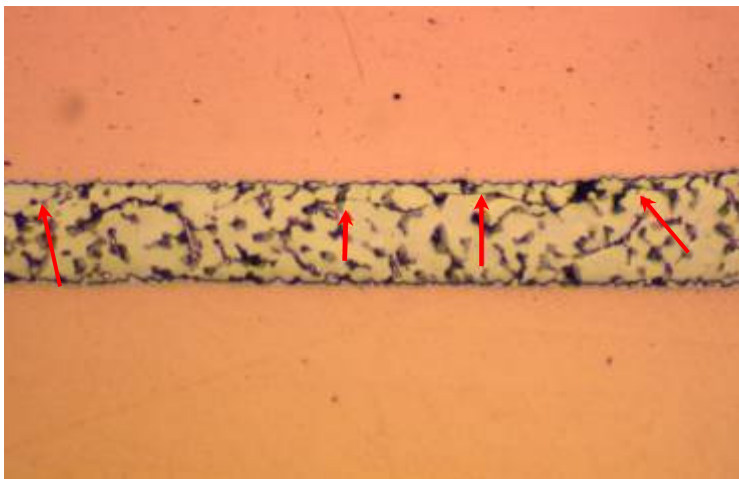
**Figure 13: board 86, U15, pin 19, 400x**

Figure 13 and 14 illustrate cracking that occurred within the bulk solder, although to greatly differing extents. Both components failed electrically, however board 86, U15 failed at another location than illustrated in figure 13. While there is cracking through the solder, it would not cause the part to fail electrically. Board 85, U57 on the other hand shows a complete crack and failure.

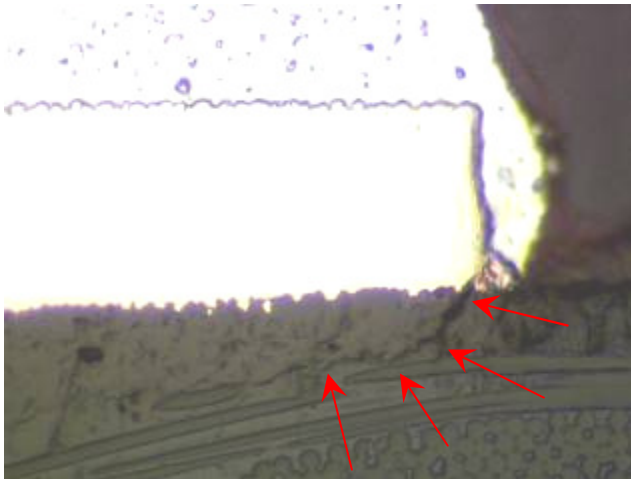
**Figure 15: board 81, U15, pin 10, 400x**

No other electrical failures were detected during drop testing, however mechanical failures in the form of pad cratering was seen on other solder joints. Board 81, U15, pin 10 (figure 15) provides a good illustration of this type of mechanical failures.

Pin 10 shows a typical example of pad cratering that was observed, even in the absence of an electrical failure.

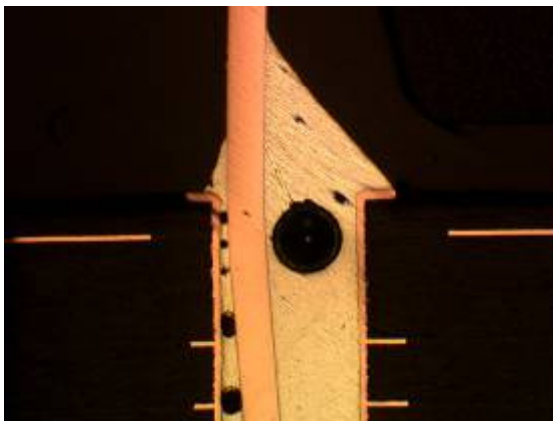
**Figure 16: board 87, U38, pin 10, 25x**

None of the PDIP-20s showed any defects related to the drop test.

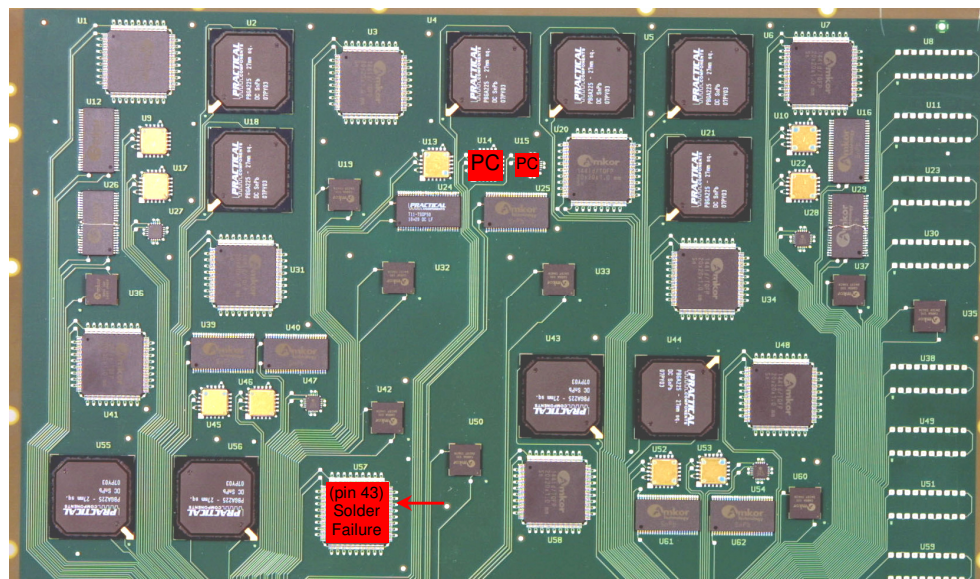
Figure 18: Location of Electrical Failures

The location of the electrical failures is illustrated in figure 18.
